PATENT ABSTRACTS OF JAPAN

(11)Publication number : 2004-085512
 (43)Date of publication of application : 18. 03. 2004

(54) DEFECT DETECTOR, AND DEFECT INSPECTION METHOD

(54) 【発明の名称】 欠陥検出装置および欠陥検査方法

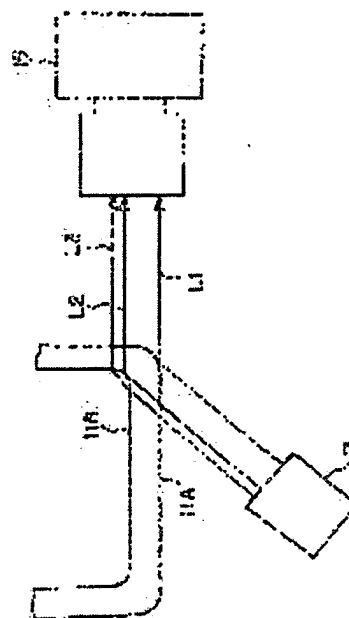
SOLUTION: In this defect detector, a projector 13 is arranged in a position where one part of irradiation light is reflected on an outer face 11A in the skirt corner part of the glass container, and where one part of the irradiation light is incident into the skirt corner part to be reflected on an inner face 11B of the bent part. An imaging device 15 is arranged in a position to photo-receive reflected light L1 on the outer face 11A in the skirt corner part and reflected light L2 on the inner face 11B. The presence of the defect is inspected based on an image picked up by the imaging device 15.

【解決手段】 欠陥検出装置において、投光器 1 3 は、照射する光の一部がガラス容器の裾コーナ部の外面 1 1 A で反射され、かつ、照射光の一部が裾コーナ部に入射して屈曲部の内面 1 1 B で反射される位置に配置される。また、撮像装置 1 5 は、裾コーナ部の外面 1 1 A の反射光 L 1 および内面 1 1 B の反射光 L 2 を受光する位置に配置される。そして、撮像装置 1 5 の撮像画像に基づいて、
